Inspection Report

Property Address:
11 Old Rodgers Ranch Rd
Pleasant Hill CA 94523

Safeguard Inspections, LLC

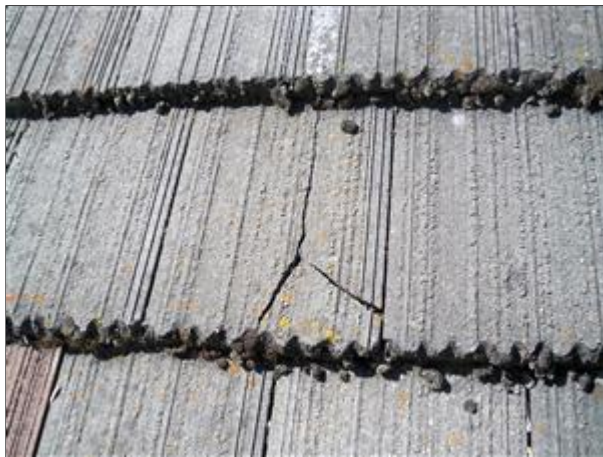
1.0 Picture 1

1.0 A couple of cracked and displaced tiles on right side rear of the house. (Picture 1) (Picture 2) Recommend replacement.

A couple of cracked and displaced tiles on right side rear of the house. (Picture 1) (Picture 2) Recommend replacement.

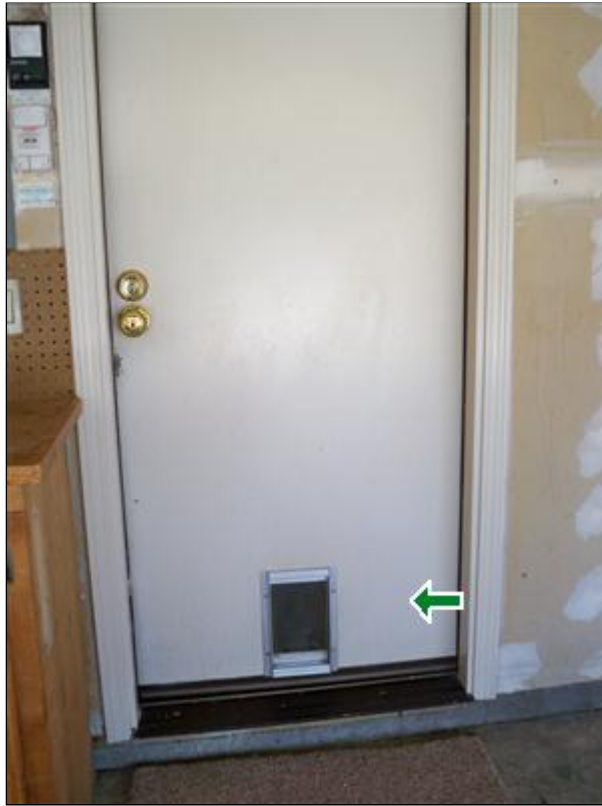
3.4 Picture 1

3.4 To assure compliance with fire safety standards, the passage door from the garage to the interior must have a self closing mechanism and must be at least one and three eights inch thick, solid wood door or one having 20-minute fire resistive construction.

The passage door has a pet door installed. This constitutes a breach in the fire resistive barrier. I recommend repair with approved materials.

The passage door has a pet door installed. This constitutes a breach in the fire resistive barrier. I recommend repair with approved materials.

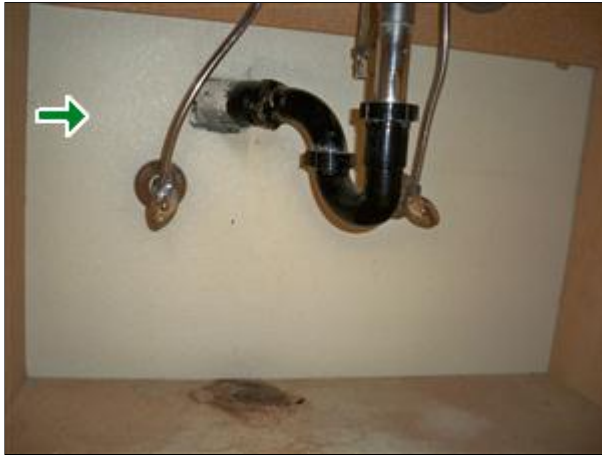
6.1 Picture 1

6.1 A small drain leak was detected in the Master Bath, under the right sink. (Picture 1) Recommend repair.

A small drain leak was detected in the Master Bath, under the right sink. (Picture 1) Recommend repair.

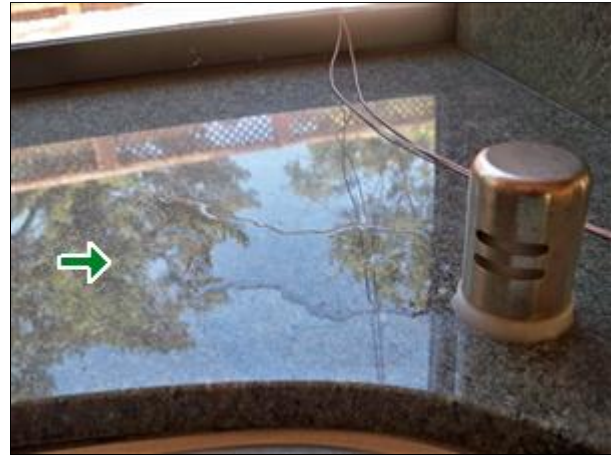
6.1 Picture 2

The dishwasher air-gap leaked onto the counter during the wash cycle(Picture 2). Recommend replacing the air-gap.

10.1 The dishwasher drain is normally equipped with an air gap fitting (the cylinder protruding above the sink). This assures the separation of supply water from wastewater. **The air gap leaked water onto the counter. Recommend replacing the air gap.**

The dishwasher air-gap leaked onto the counter during the wash cycle(Picture 2). Recommend replacing the air-gap.

The dishwasher drain is normally equipped with an air gap fitting (the cylinder protruding above the sink). This assures the separation of supply water from wastewater. The air gap leaked water onto the counter. Recommend replacing the air gap.

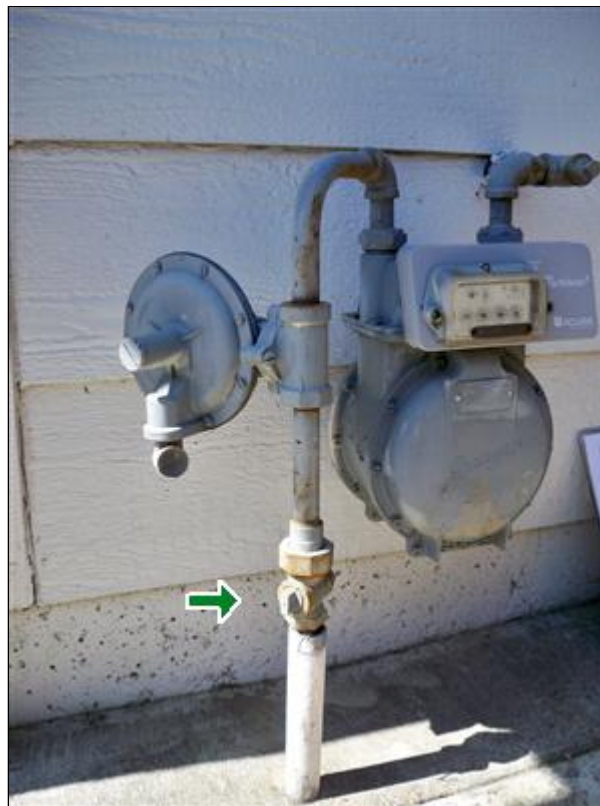
6.5 Picture 1

6.5 The gas meter is located on the right side of the garage. The gas shut-off is located on the riser between the ground and the gas meter. To turn off gas, turn the valve 90 degrees, in either direction, to the horizontal position.(Picture 1)

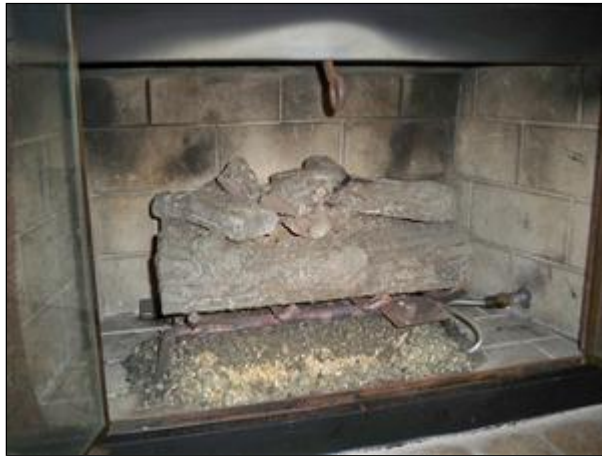
8.5 Picture 1

8.5 The fireplace is equipped with a damper lock to keep it in the open position. This is to prevent accidental use of gas fireplace without opening the damper, which could result in build-up of carbon monoxide.

Gas insert was not tested for functionality. Please refer to chimney report for further information.
